### PROGRESS REPORT NO. 1

### ARCHAEOLOGICAL INVESTIGATION 95-101 GEORGE STREET, PARRAMATTA

### WEEK 1: 14-18 June 2005

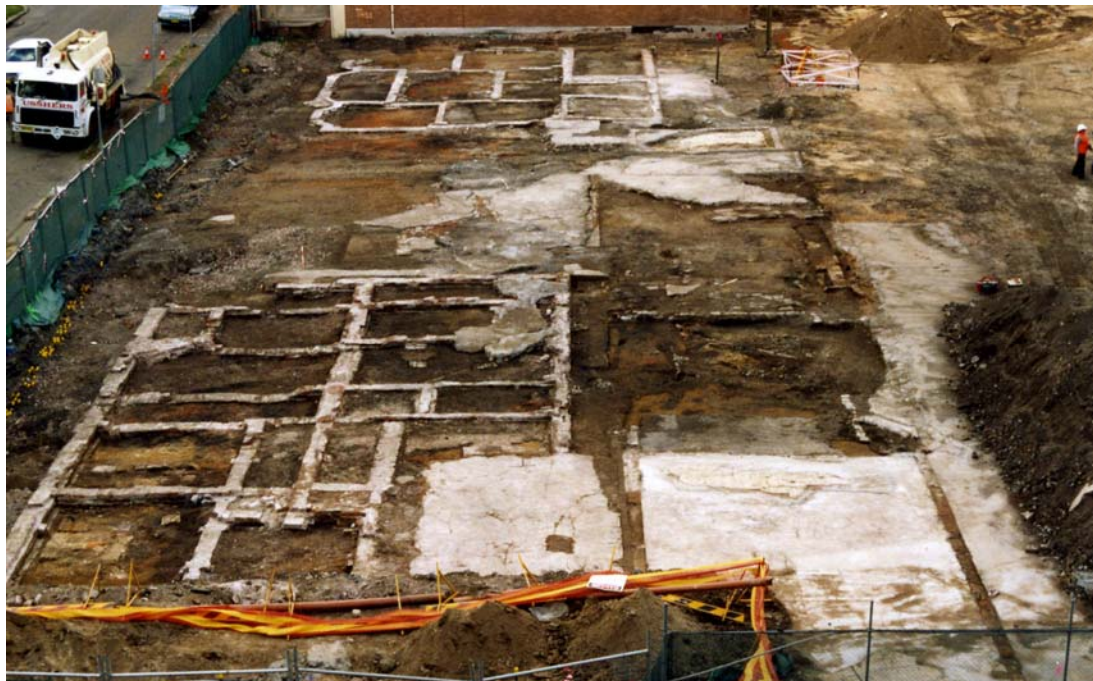
View south across the excavation area exposed to date showing the buildings at 99 and 101 George Street and 9 Charles Street.
